# A Unique Solution for Repairs during a 5-Day Outage

Northern Florida

Submitted by Premier Corrosion Protection Services, Inc.

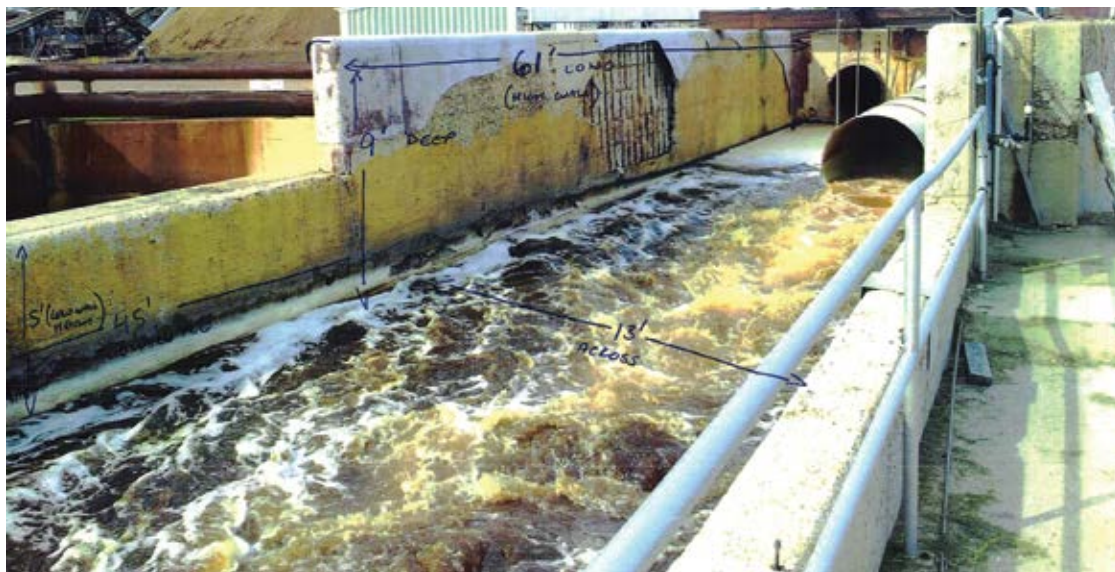
Considerable deterioration of concrete walls and slab due to aggressive chemicals that are discharged into Mix Box at any given time

Over the years, there has been considerable deterioration of the concrete walls and slab due to the aggressive chemicals that are discharged into the Mix Box at any given time. In addition to the damaged walls and slab, a severely damaged underwater dike, made from cement bags used to aerate the chemicals and air, had to be redesigned and replaced.

The Mix Box is subject to any number of corrosive fumes at any given time; over the life of the plant, these fumes had caused severe spalling, delamination, and corrosion of the reinforcing steel. Initial testing showed that the concrete had in fact severely deteriorated and that the existing exposed reinforcing steel had to be enhanced.

All spalls were prepared per ICRI Technical Guideline No. 310.1R-2008. All concrete cutting was completed creating right angles per ICRI standards. Contaminated concrete was removed from behind the reinforcing steel and an epoxy bonding agent/corrosion inhibitor was applied. Additional reinforcing steel and wire mesh were installed and formwork was erected. With this in place, a

high-strength, fast-curing, silica-fume-enhanced polymer concrete was then used to fill the prepared area to flush with the existing surface.

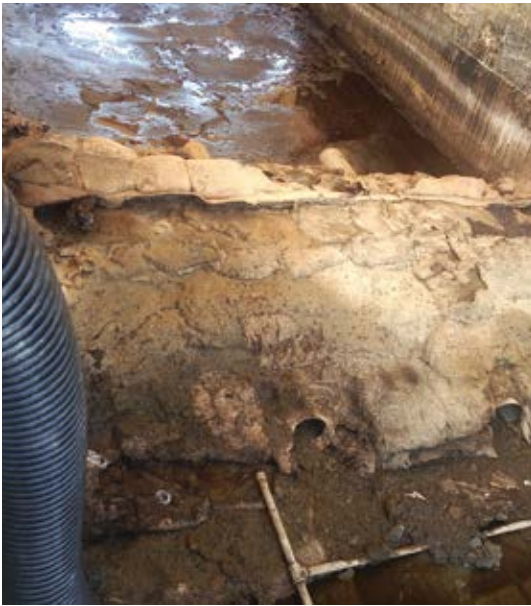
*Condition of dike once Mix Box was drained*

Because the Mix Box was in constant use and would not be available for inspection until the planned plant shutdown, there were several conditions that became apparent once the repair began. The severe deterioration of the original dike and the expanse of the delamination were surprising.

and ACI 440.2R-08, “Guide for the Design and Construction of Externally Bonded FRP Systems for Strengthening Concrete Structures.” In addition, a new fiber-reinforced polymer (FRP) dike had to be designed, fabricated, and installed to replace the old dike.

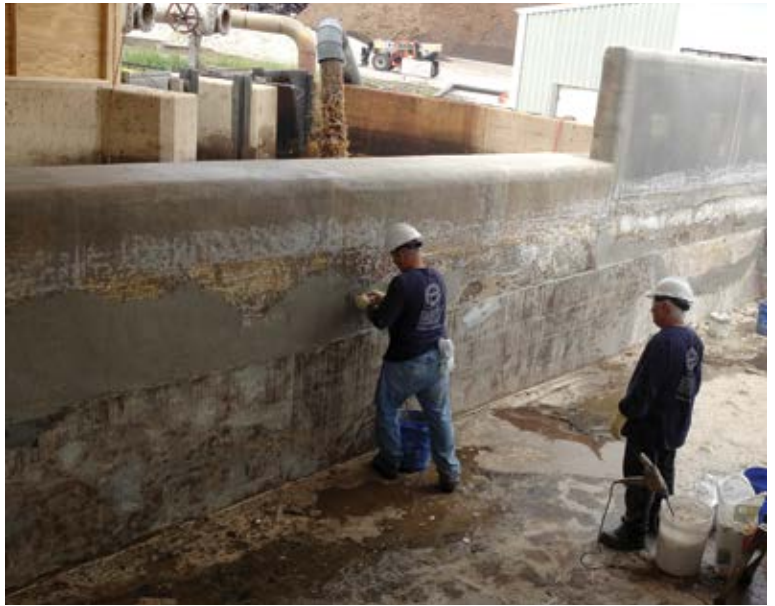
*Surface preparation underway*

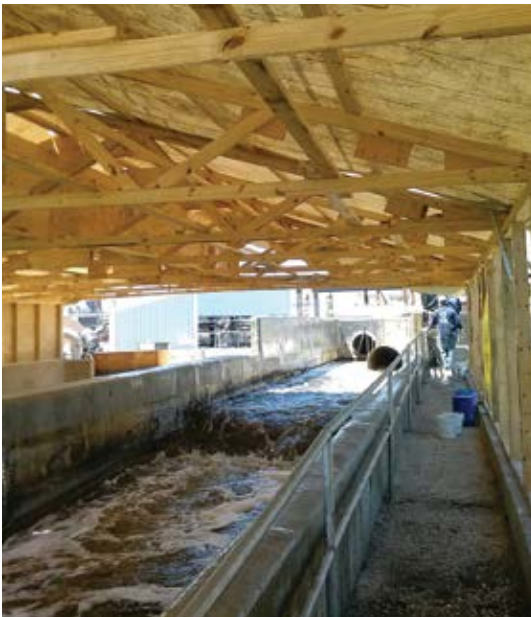
*Temporary plywood roof erected over Mix Box to allow for work to continue day and night*

Additionally, because of the limited schedule, a temporary plywood roof was erected over the Mix Box to allow for work to continue day and night, even in inclement weather.

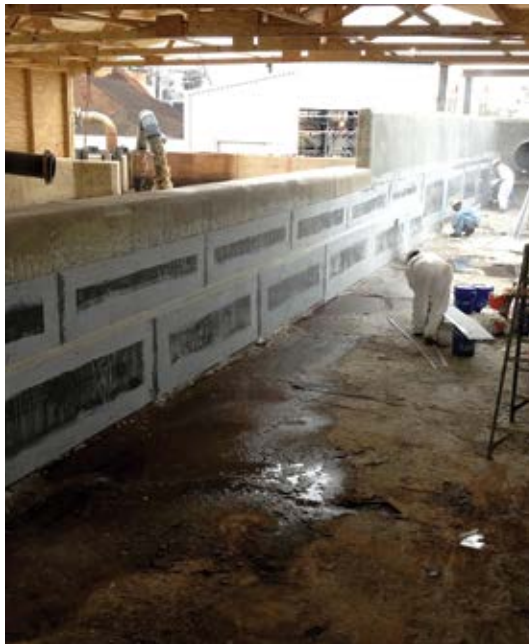
*FRP panels prepared to be welded to each other*

using stainless steel fasteners. Each panel was welded to the other using hand-applied FRP straps welded to the FRP plates and continued over the top of the repaired wall to lock in the FRP panels and to prevent chemicals from damaging the concrete wall when it spilled. A smooth, tinted wax coat finish completed the repair.

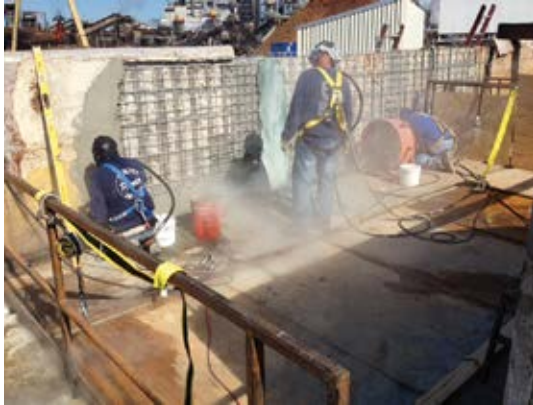
Columns are installed first to receive formwork for wall

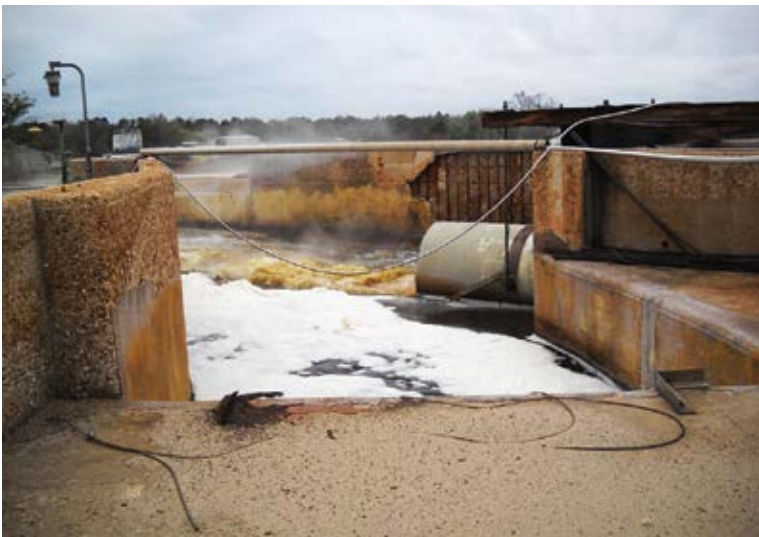
New FRP dike installed

The ability to weld the FRP sheets installed over the repaired walls, floor, and dike made this a seamless liner from top to bottom for its entire length, effectively protecting the concrete from further chemical attacks and providing a long-lasting solution to the client.

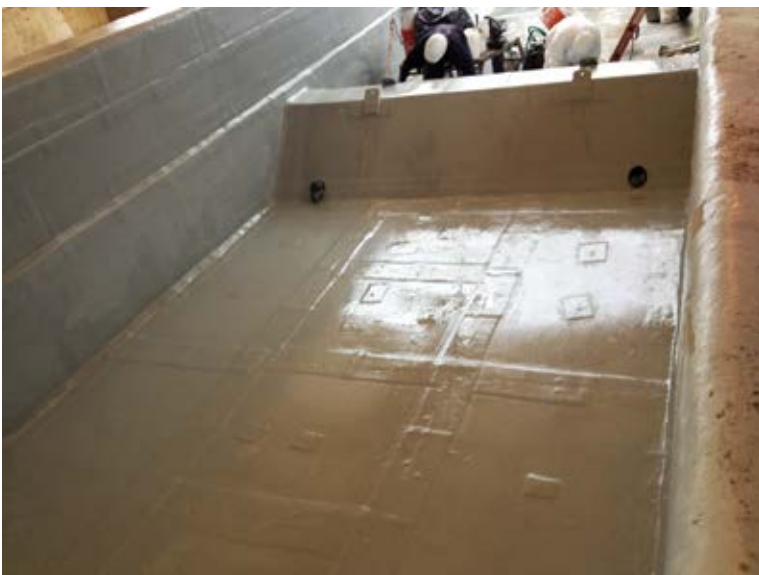
Project complete
