The Premier Newsletter

Issue No. 6

In this newsletter we are showing repairs to two different tanks. The first is a 12'-0" diameter 54% Phos acid steel rubber-lined tank with a "hole" in the roof. The hole turned out to be 8'-0" in diameter. To complicate the repair, the catwalk, grating and piping is less than two feet above the tank. The solution was to repair the tank from the inside. We accomplished this by using shop fabricated FRP panels and FRP support beams, essentially building a new roof. Next we removed the rubber two feet down the tank wall and fibreglassed the walls tying the lining to the new FRP roof. All seams were covered with 1/4" FRP welds. Finally the entire FRP repair was given a corrosion barrier and a pigmented wax coat. The entire project was completed within the client's four day shut down!

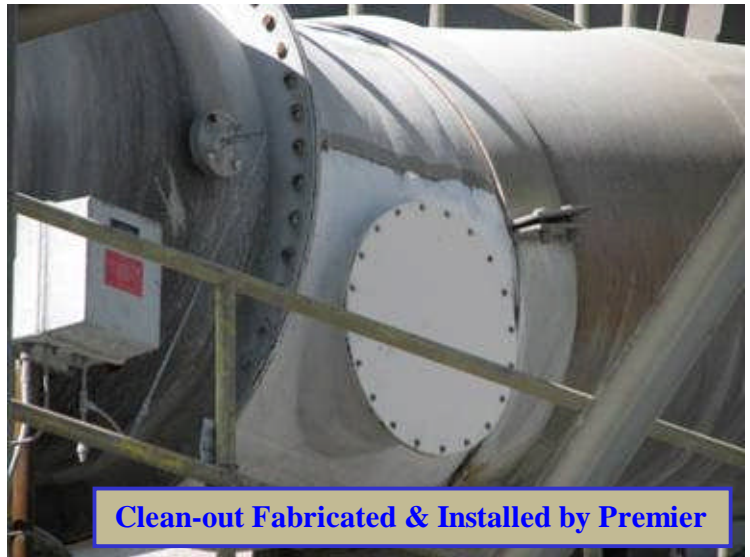
Clean-out Fabricated & Installed by Premier

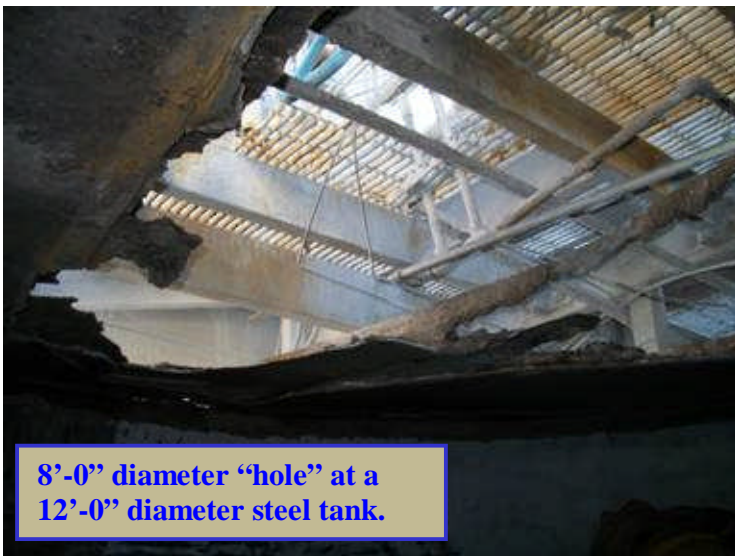
8'-0" diameter "hole" at a 12'-0" diameter steel tank.

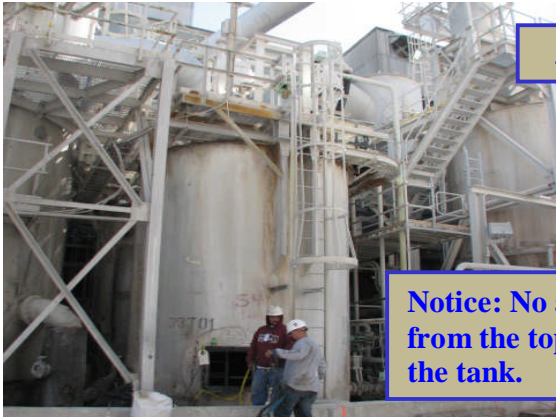
54% Phos Acid Tank

Notice: No access from the top of the tank.

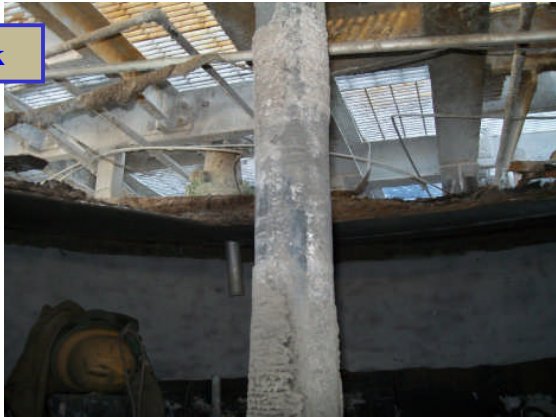
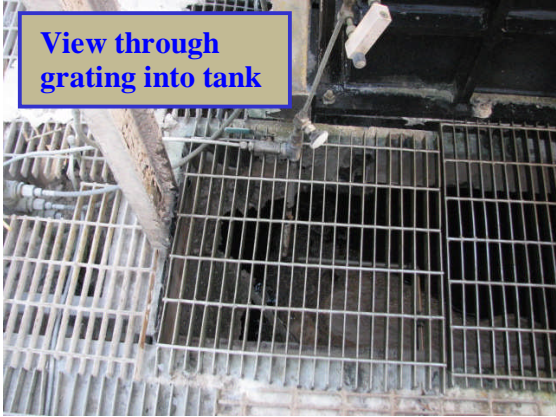
View through grating into tank

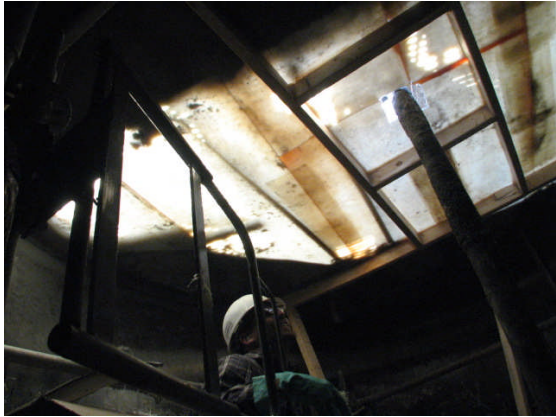
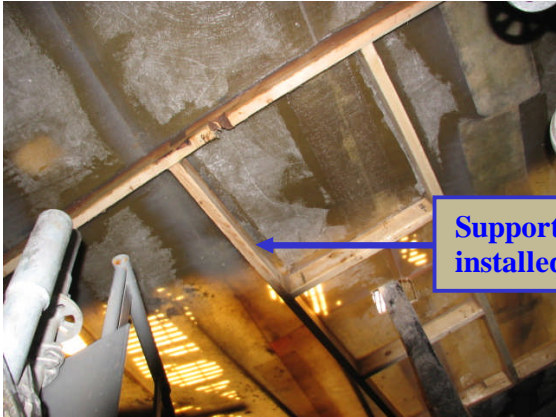
Support grid installed.

Base coat

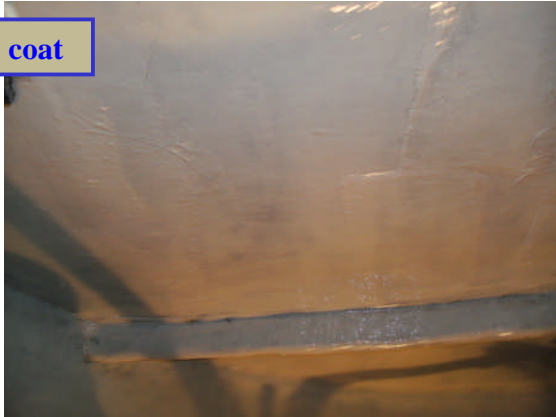
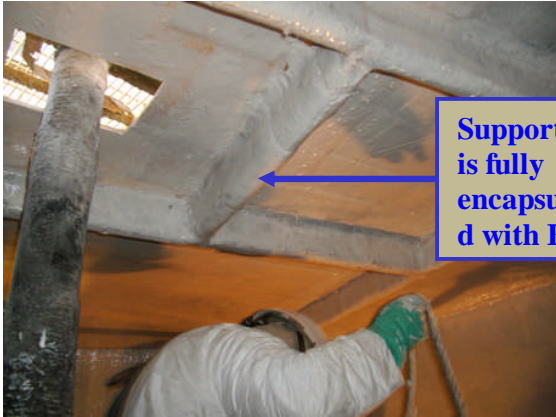
Support grid is fully encapsulated with FRP.

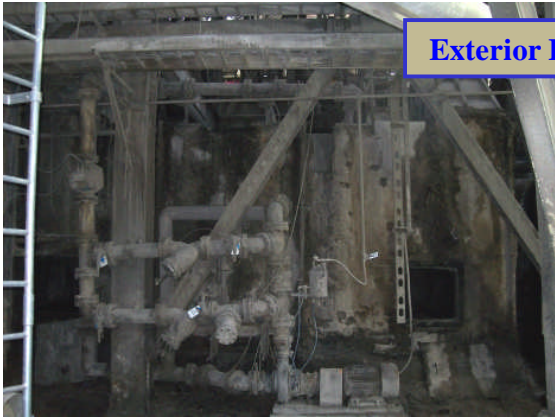
Exterior FRP lining of a Prayon Scrubber Tank

The second project we are showcasing is a repair to the exterior of a prayon scrubber tank. This steel tank had multiple holes on the lower portion of the tank which were caused by the corrosive environment. The number of equipment and vessels surrounding the prayon tank made this a very restricted space to work around. Major damaged areas were covered with prefabricated FRP panels. A corrosion barrier was installed against the prepared exterior steel walls and roof. Multiple layers of FRP material saturated with vinyl-ester epoxy resin was installed and a pigmented wax coat finish was applied to make this tank better than new.

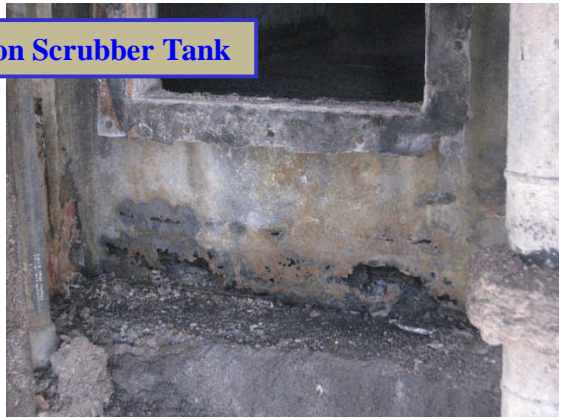
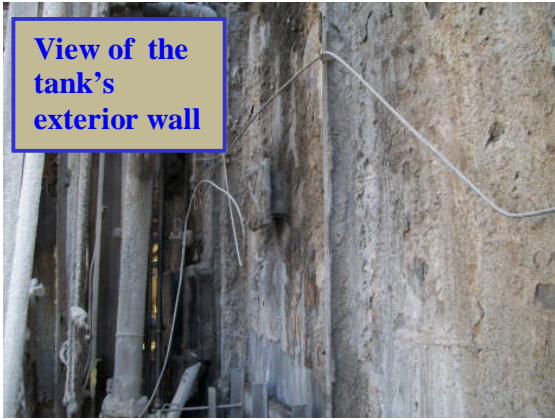
View of the tank's exterior wall

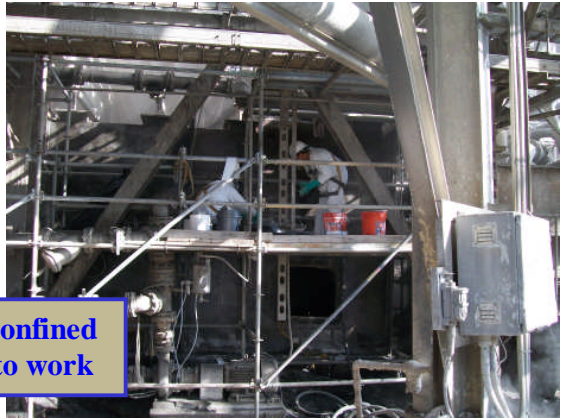
Very confined space to work

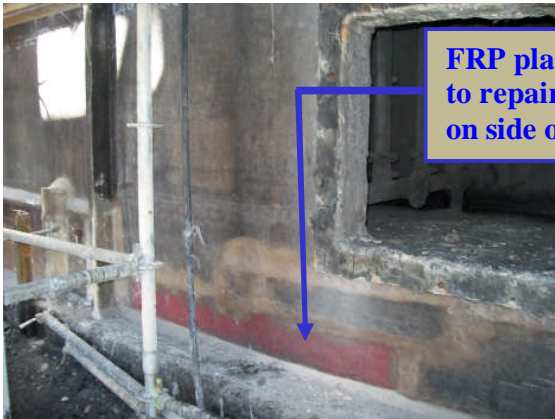
FRP plate used to repair hole on side of tank

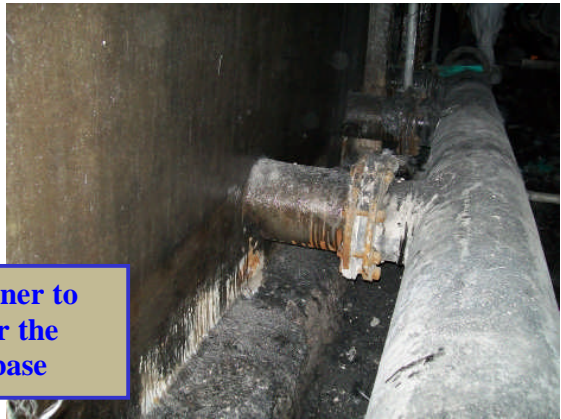
FRP liner to go over the conc. base

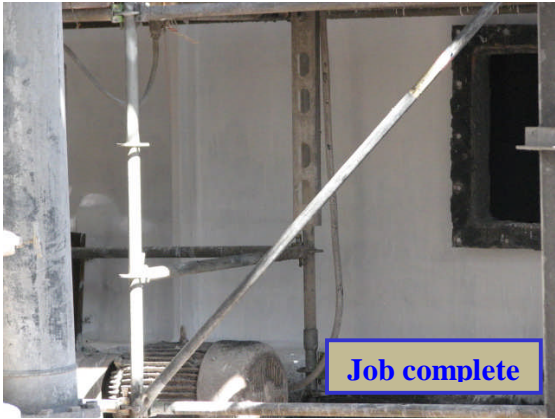
Job complete

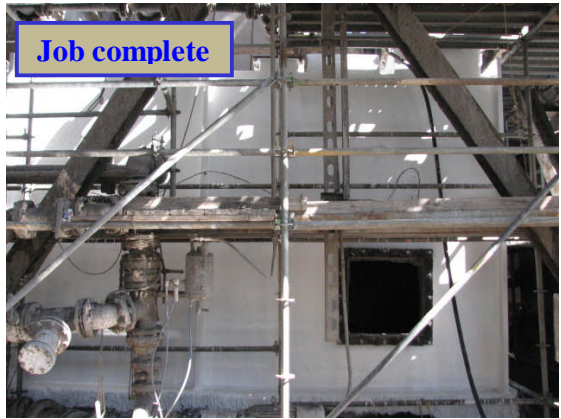
Job complete
